QA-261

Palmer Andrew House
Centreville
Private

INVENTORY FORM FOR STATE HISTORIC SITES SURVEY

PALMER ANDREW HOUSE
CENTREVILLE, MARYLAND

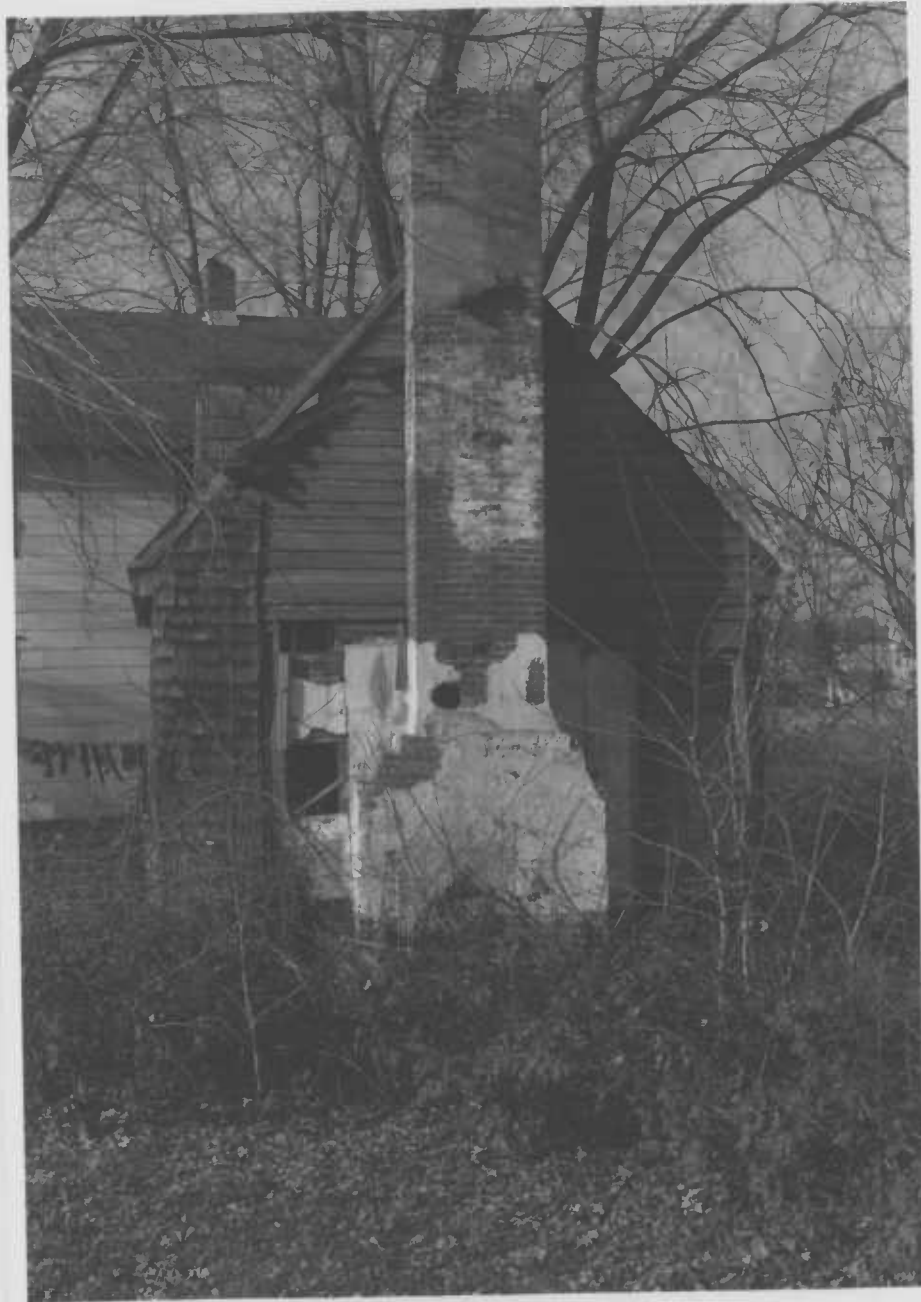
Situated on the east side of Chesterfield Avenue near the intersection with Corsica Neck Road, this small story-and-a-half frame dwelling overlooks a tidal marsh feeding into Corsica Creek. The front, three bay facade faces Chesterfield Avenue, while the rear, two bay facade overlooks the marsh. Scars remain on the southeast gable to indicate there was at one time a frame wing added to that end of the house.

The chimney has been rebuilt, as the brickwork above the first floor sill is laid in stretcher bond of decidedly later date. The small size of the fireplace in the existing building and the presence of a second fireplace at a slightly lower level on the exterior of the chimney, combined with the general character of the brickwork, would suggest that the original chimney was taken down and rebuilt when the frame addition was constructed.

QA-261 Palmer Andrew House
Centerville, Md.
Orlando Ridout V, 1978 (MHT)
Southeast gable, camera facing NW
